Inventory Data:										
Structure Name	#49 Joe Trudeau Bridge									
Main Hwy/Road#		On <input checked="" type="checkbox"/>	Under	Crossing Type	Navig. Water Rail	Water Road	Non-Navig. Water Ped.	Other		
Hwy/Road Name	Courneya Road									
Structure Location	0.5km west of Allore Road									
Latitude	44.483208°N			Longitude	77.227504°W					
Owner(s)	Municipality of Tweed			Heritage Designation:	Not Cons. <input checked="" type="checkbox"/>	Cons./not App. Desig./not List	List/not Desig. Desig. & List			
MTO Region	Eastern			Road Class:	Freeway	Arterial	Collector	Local <input checked="" type="checkbox"/>		
MTO District	Kingston			Posted Speed	80 km/h		No. of Lanes	1		
Old County				AADT			% Trucks			
Geographic Twp.				Inspection Route Sequence						
Structure Type	Half-Through Truss			Interchange Number						
Total Deck Length	19.5m		(m)	Interchange Structure Number						
Overall Str. Width	5.5m		(m)	Min. Vertical Clearance	2.3		(m)

Field Inspection Information:	
Date of Inspection:	June 2, 2022
Inspector:	Abdul Rahman Stott
Others in Party:	Cody Chambers
Equipment Used:	Camera and hand tools
Weather:	Overcast
Temperature:	16°C

BRIDGE PHOTOGRAPHS

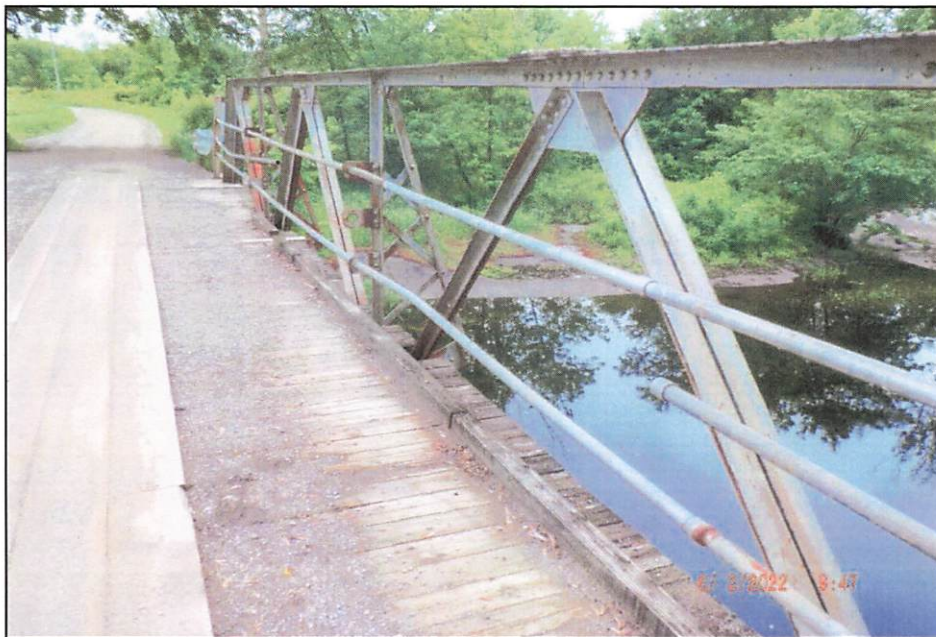
Photo 2: South Tuss and Barrier with Missing Tube Railing

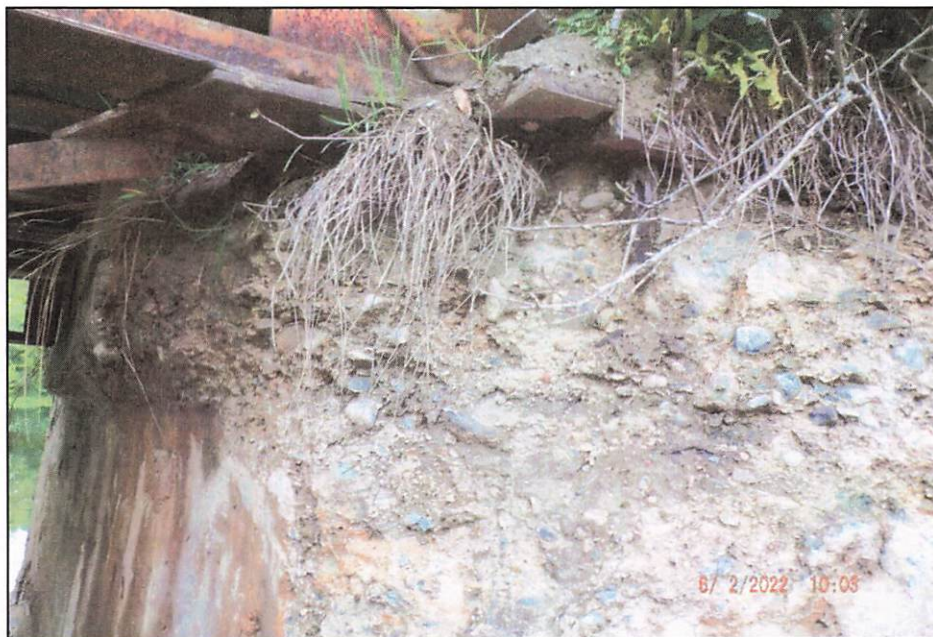
Photo 6: Loss of Truss Bearing at Southeast Abutment Wall

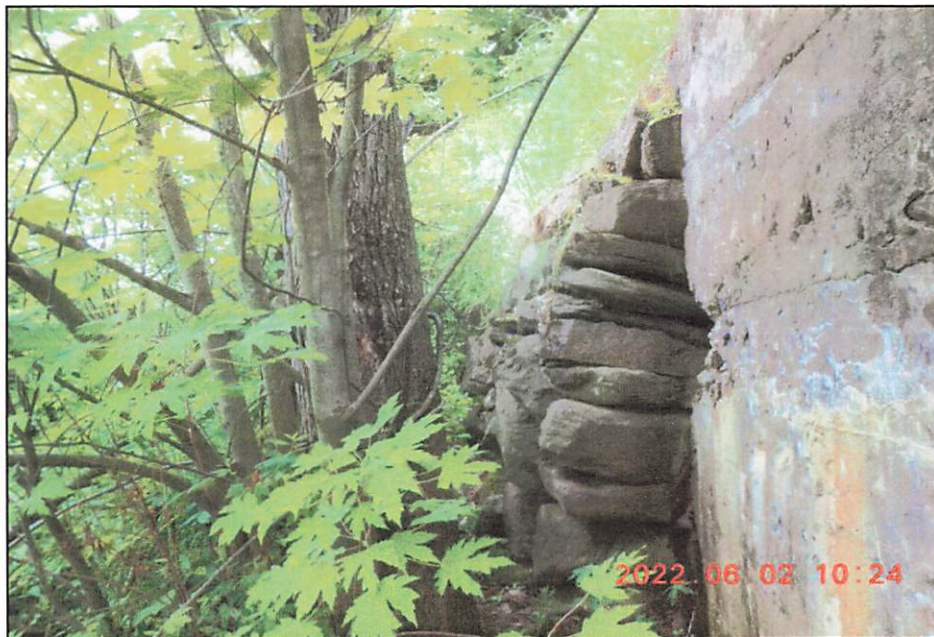
Photo 8: Bulging of Southwest Retaining Wall

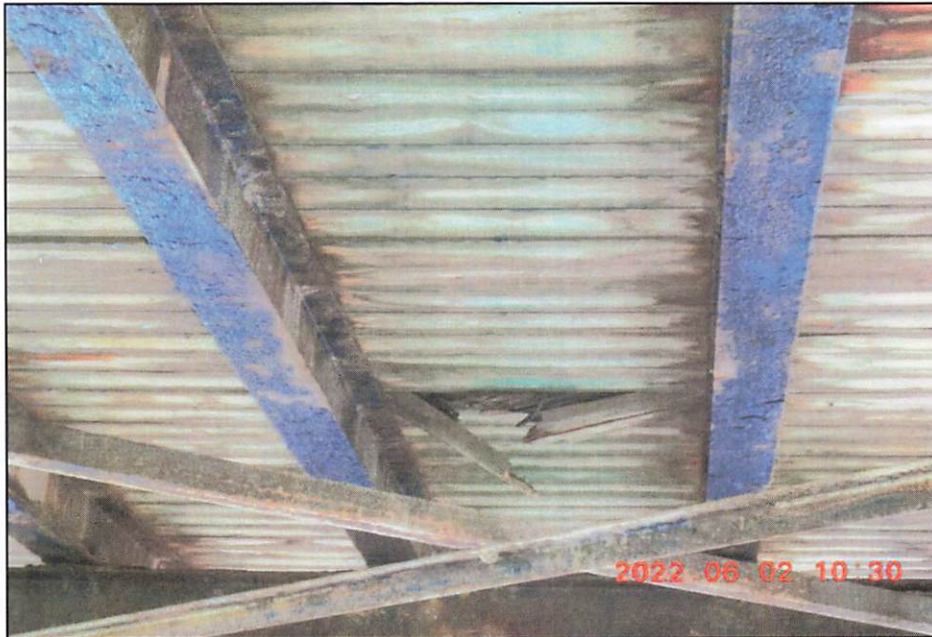
Photo 9: Localized Deck Failure

- Replace structure to improve level-of-service (1-5 yrs.)
- Repair localized deck failure (NOW)
- Remove overgrowth at abutments as part of structure maintenance
