Inventory Data:										
Structure Name	<span style="border: 1px solid black; padding: 2px;">#6 Lost Channel Bridge, Lot 8 Conc V/VI, Hungerford</span>									
Main Hwy/Road#	<span style="border: 1px solid black; padding: 2px;">37</span>	On <input checked="" type="checkbox"/>	Under	Crossing Type	Navig. Water Rail	Water Road	Non-Navig. Ped.	Water Other		
Hwy/Road Name	<span style="border: 1px solid black; padding: 2px;">Lost Channel Road</span>									
Structure Location	<span style="border: 1px solid black; padding: 2px;">2.70 km E of highway #37</span>									
Latitude	<span style="border: 1px solid black; padding: 2px;">44.421603°N</span>	Longitude	<span style="border: 1px solid black; padding: 2px;">77.306535°W</span>							
Owner(s)	<span style="border: 1px solid black; padding: 2px;">Municipality of Tweed</span>	Heritage Designation:	Not Cons. <input checked="" type="checkbox"/>	Cons./not App.	List/not Desig.

Field Inspection Information:	
Date of Inspection:	May 12, 2022
Inspector:	Abdul Rahman Stott
Others in Party:	Cody Chambers
Equipment Used:	Camera and hand tools
Weather:	Sunny
Temperature:	23°C

The structure is generally in poor condition on account of extensive s

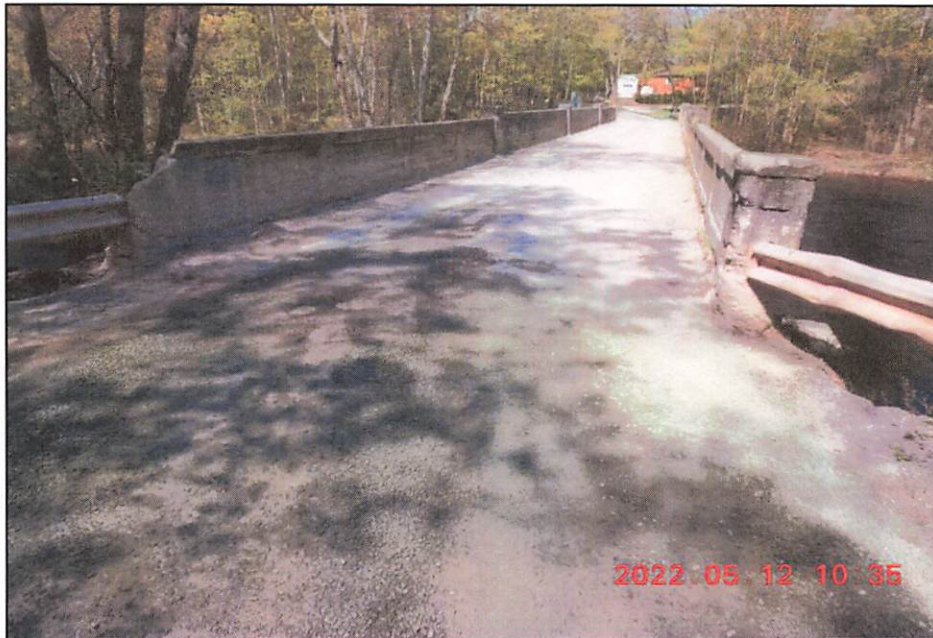
*Photo 1: East Approach and Deck Top Looking West*

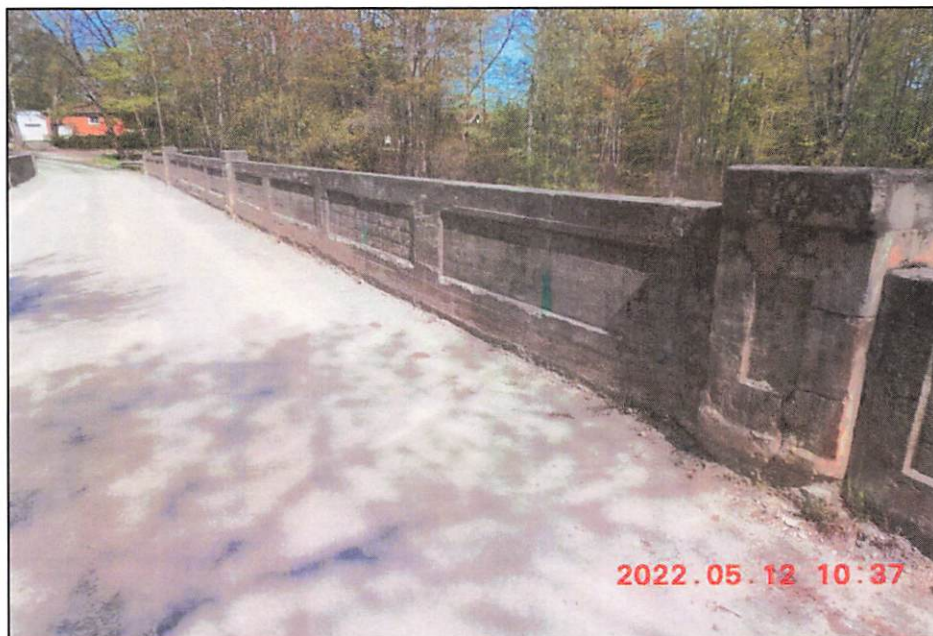
*Photo 2: North Interior Barrier Wall Looking West*

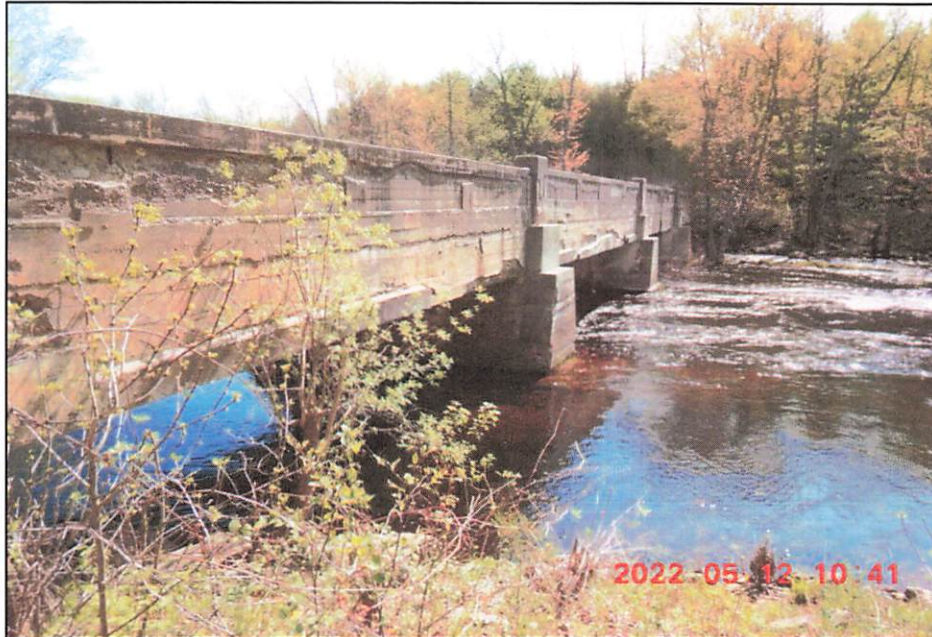
*Photo 3: South Exterior Barrier Wall, Fascia, and T-Beam Looking East*

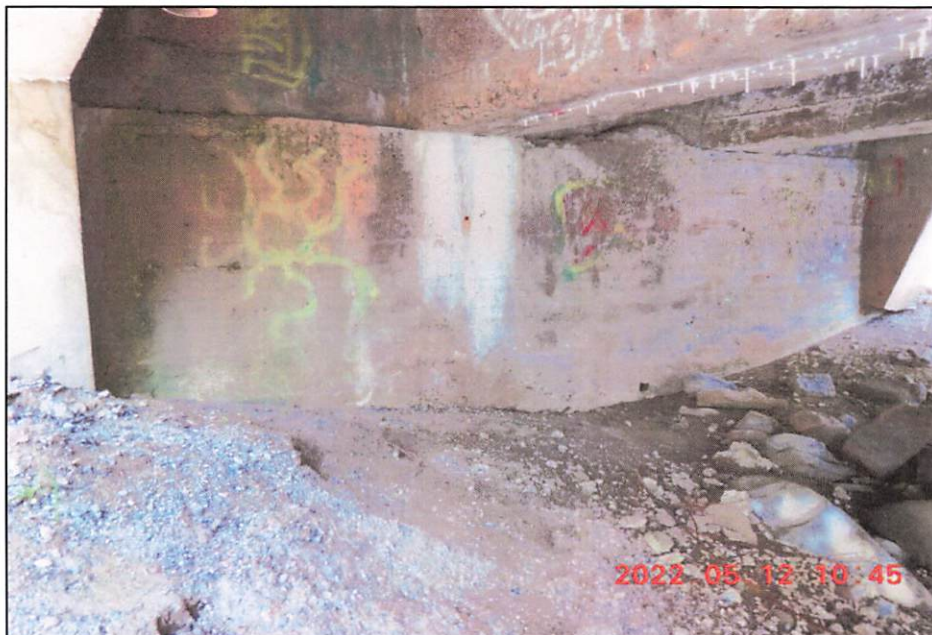
*Photo 4: Efflorescence on West Abutment Wall and Scaling and Stalactites on T-Beam*

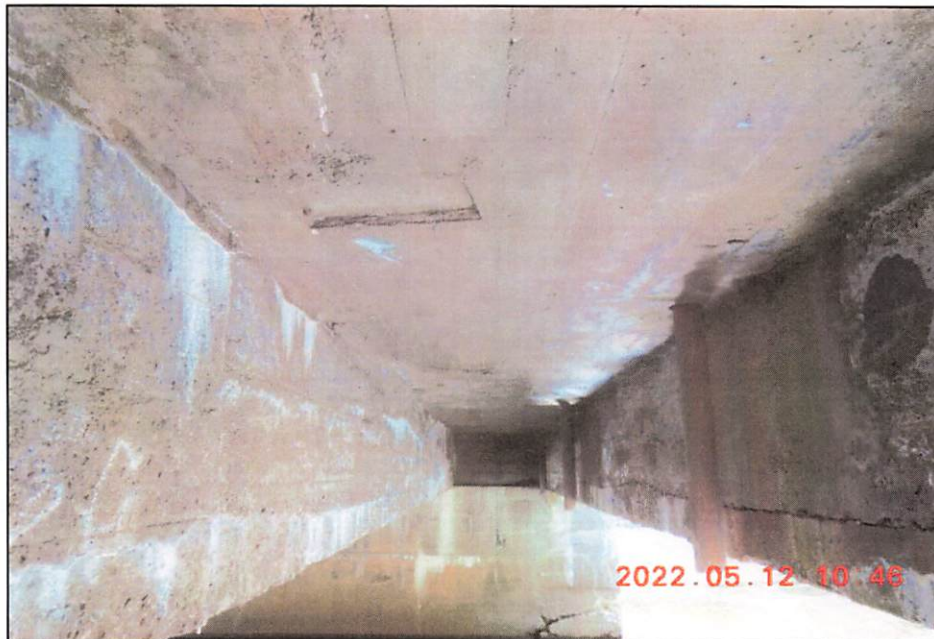
*Photo 5: Cracking and Efflorescence on West Span Inter T-Beams and Soffit*

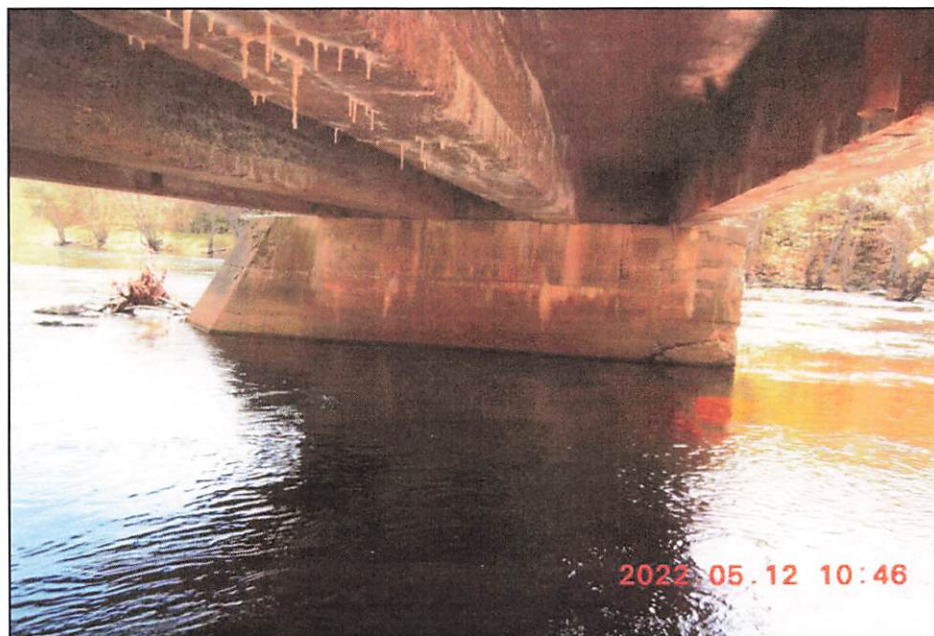
*Photo 6: Spall on West Pier West Face and Scaling, Cracking, and Stalactites on T-Beams*

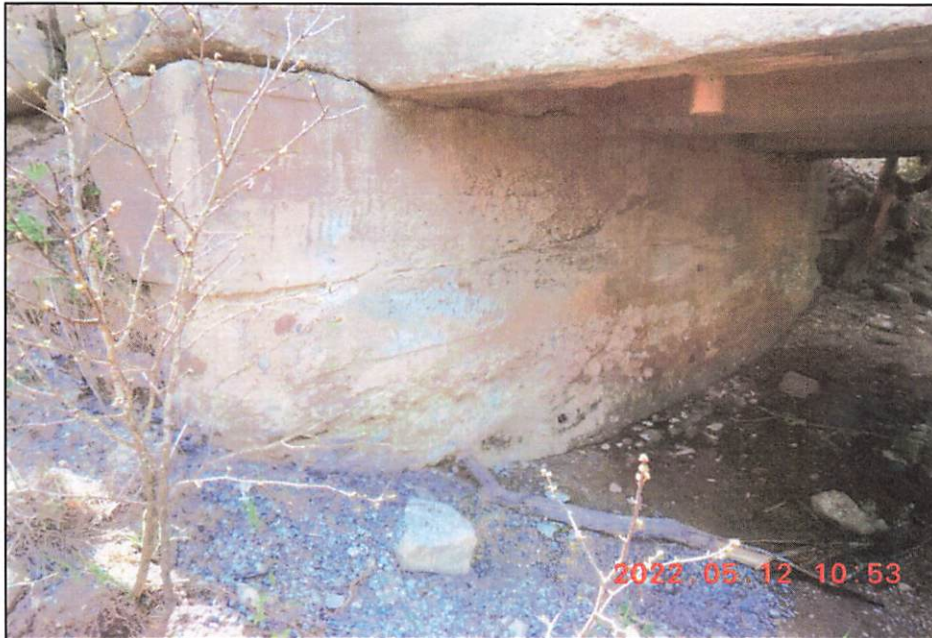
*Photo 7: Erosion, Scaling and Cracking on East Abutment Wall*

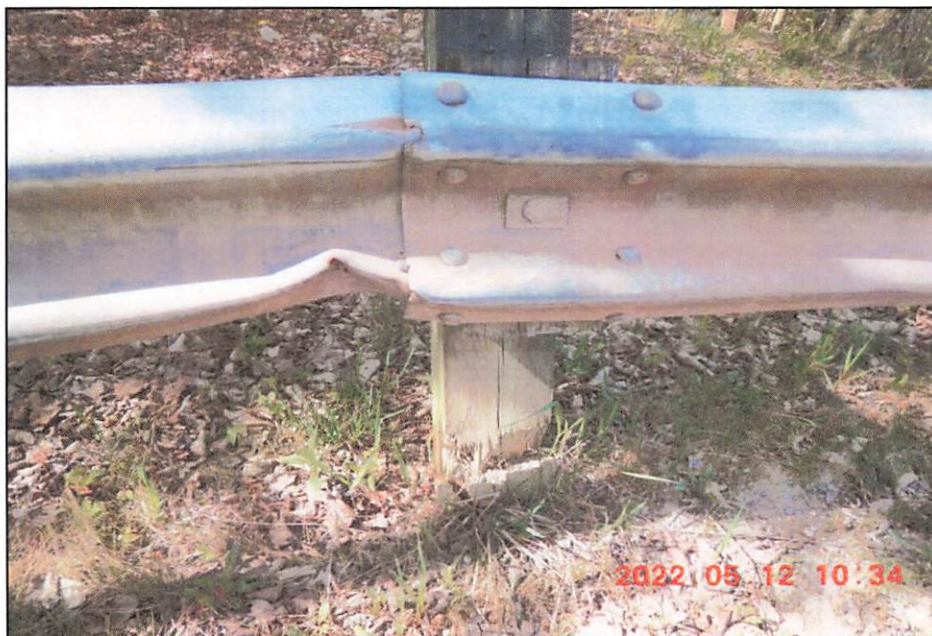
*Photo 8: Fractured Post and Deformation on Southeast Approach Barrier*

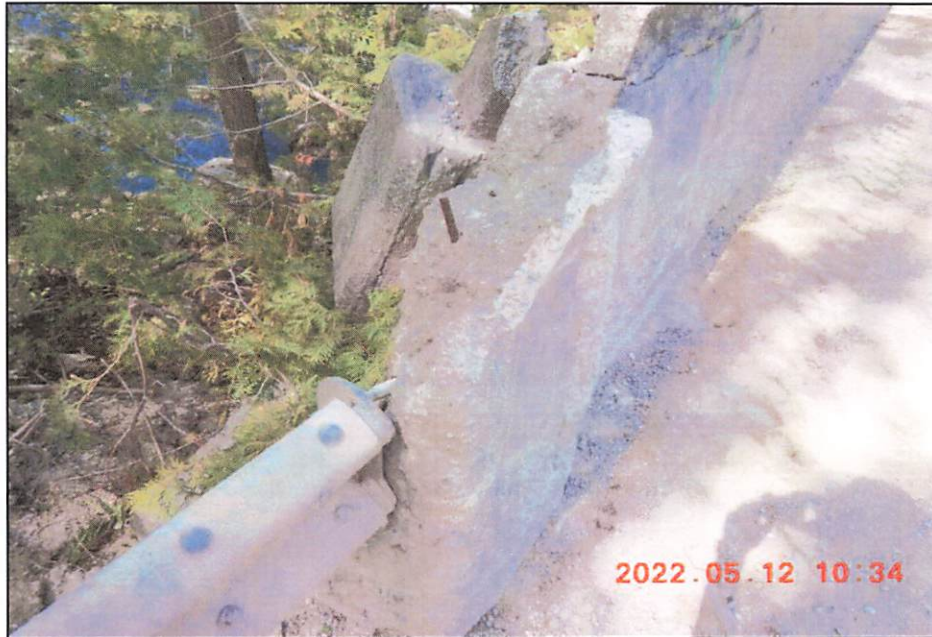
*Photo 9: Spalling on Southeast Barrier Post*

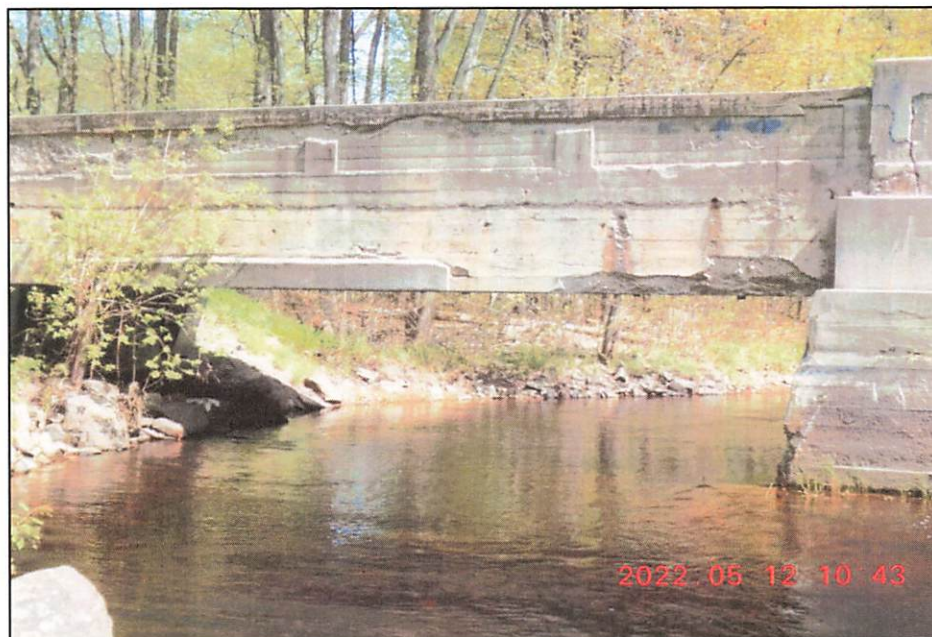
*Photo 10: Spalling with Exposed Rebar and Patch on West Span South Exterior T-Beam*

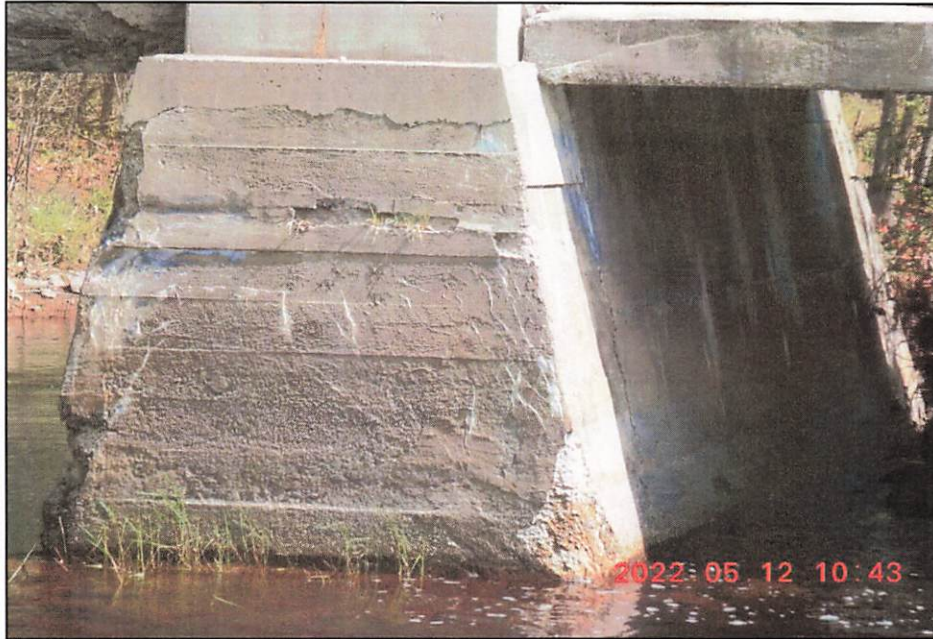
*Photo 11: Scaling, Erosion, and Cracking with Efflorescence on West Pier South Face*

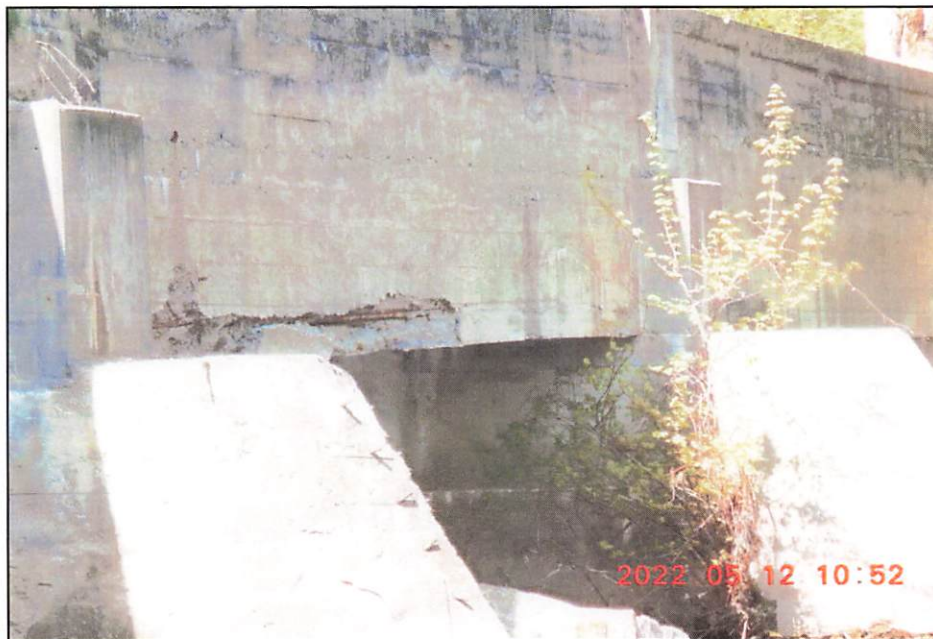
*Photo 12: Spalling with Exposed Rebar on North Exterior T-Beam*

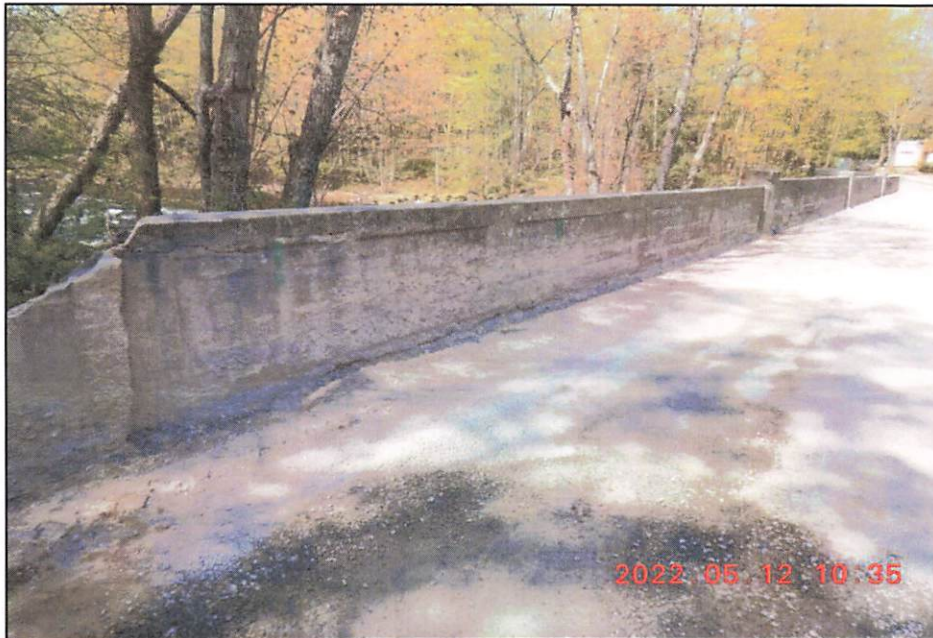
*Photo 13: Scaling on South Interior Barrier Wall*

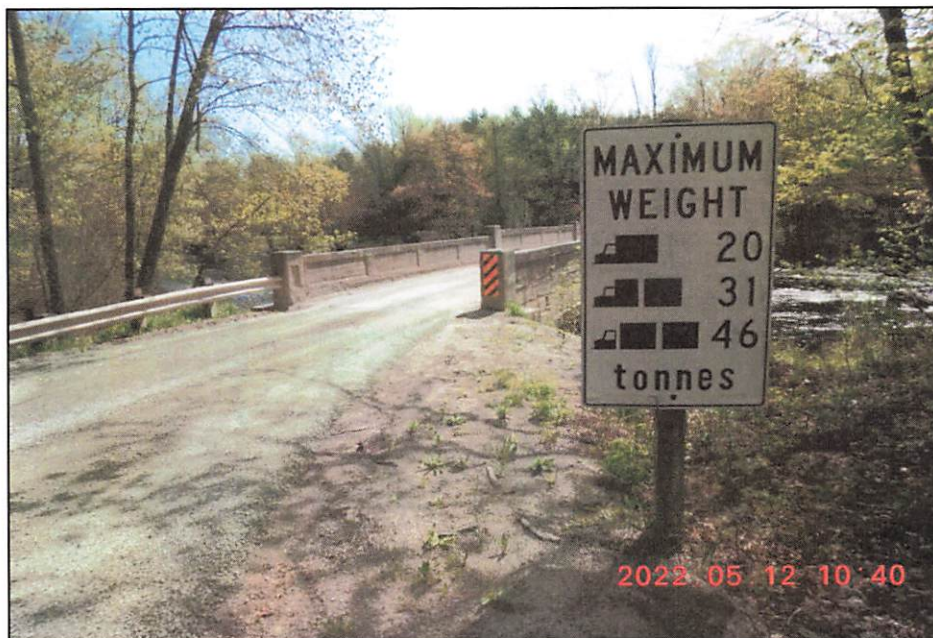
*Photo 14: Old Maximum Tonnes Sign and West Approach*

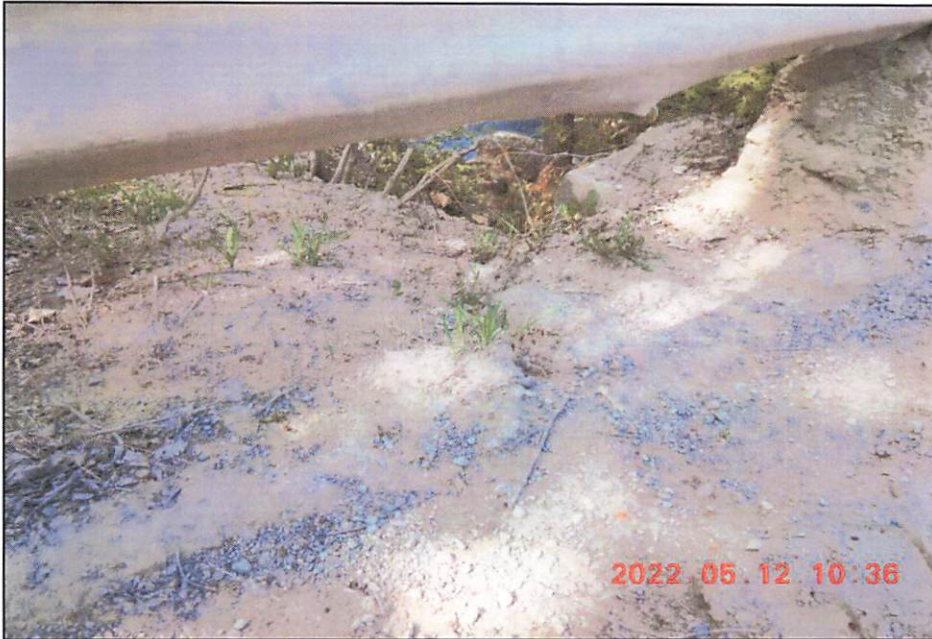
*Photo 15: Erosion/Washout on Southeast Approach*
